### SECTION III

## SACRAMENTO STATE CAPITOL RESTORATION

Sacramento, California

1976 - 1980

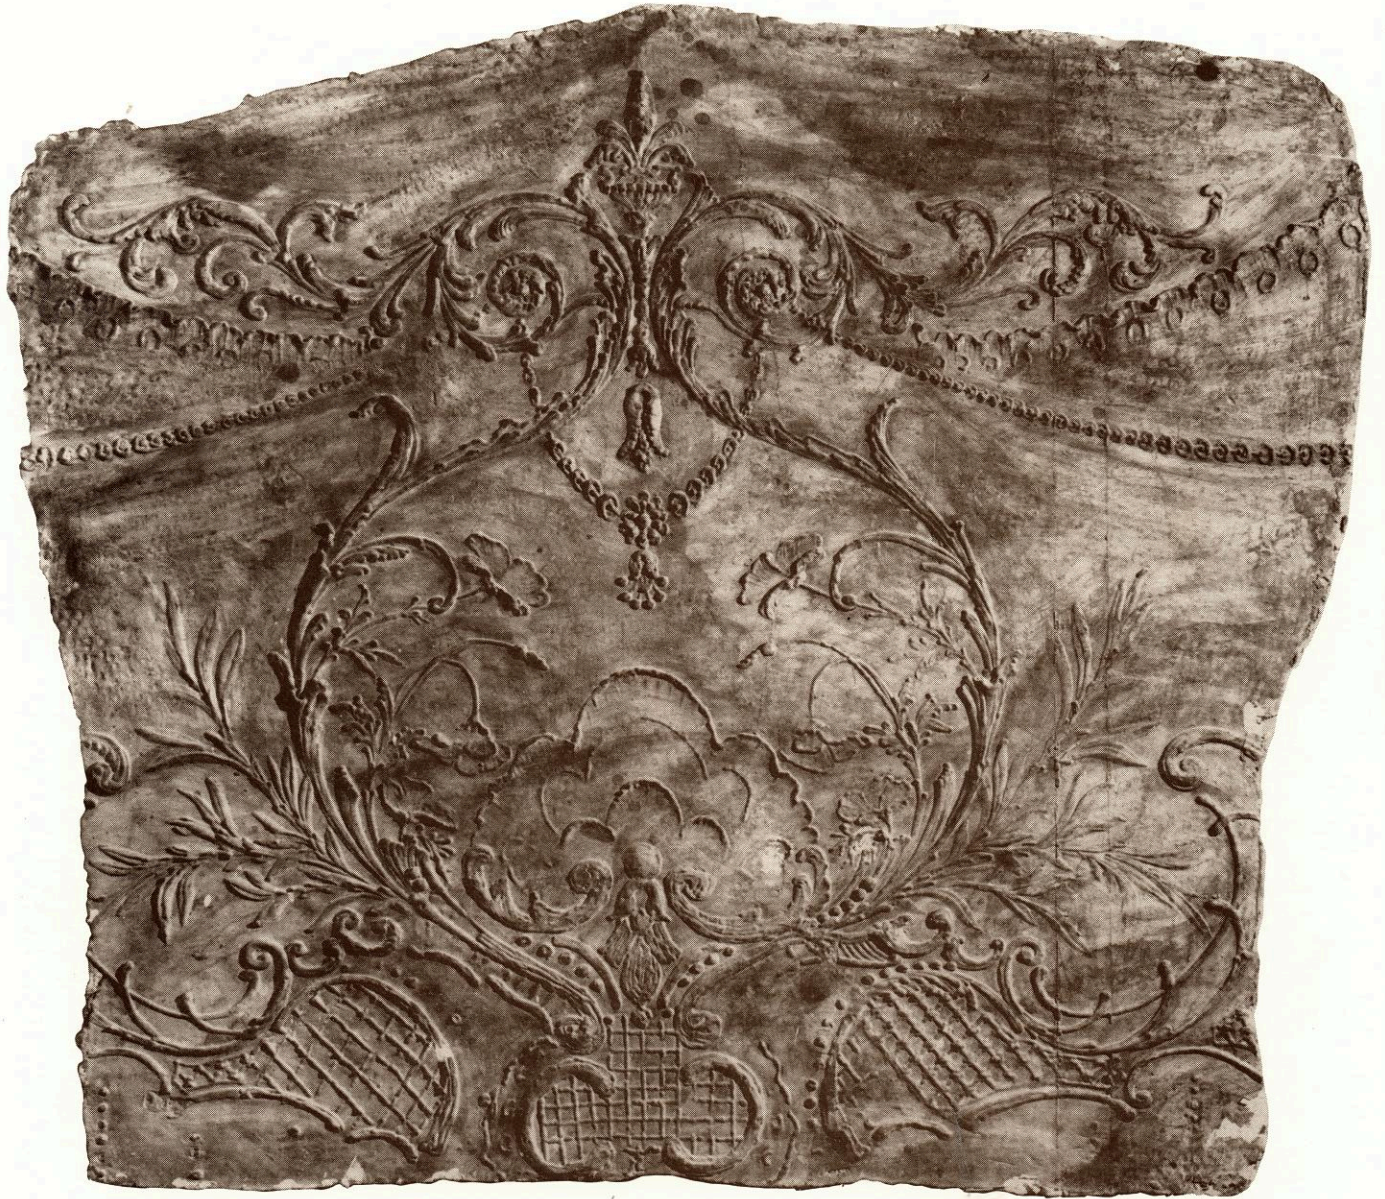
Archival Ceiling - This is a large surviving sample showing the original craftsmanship and technique.

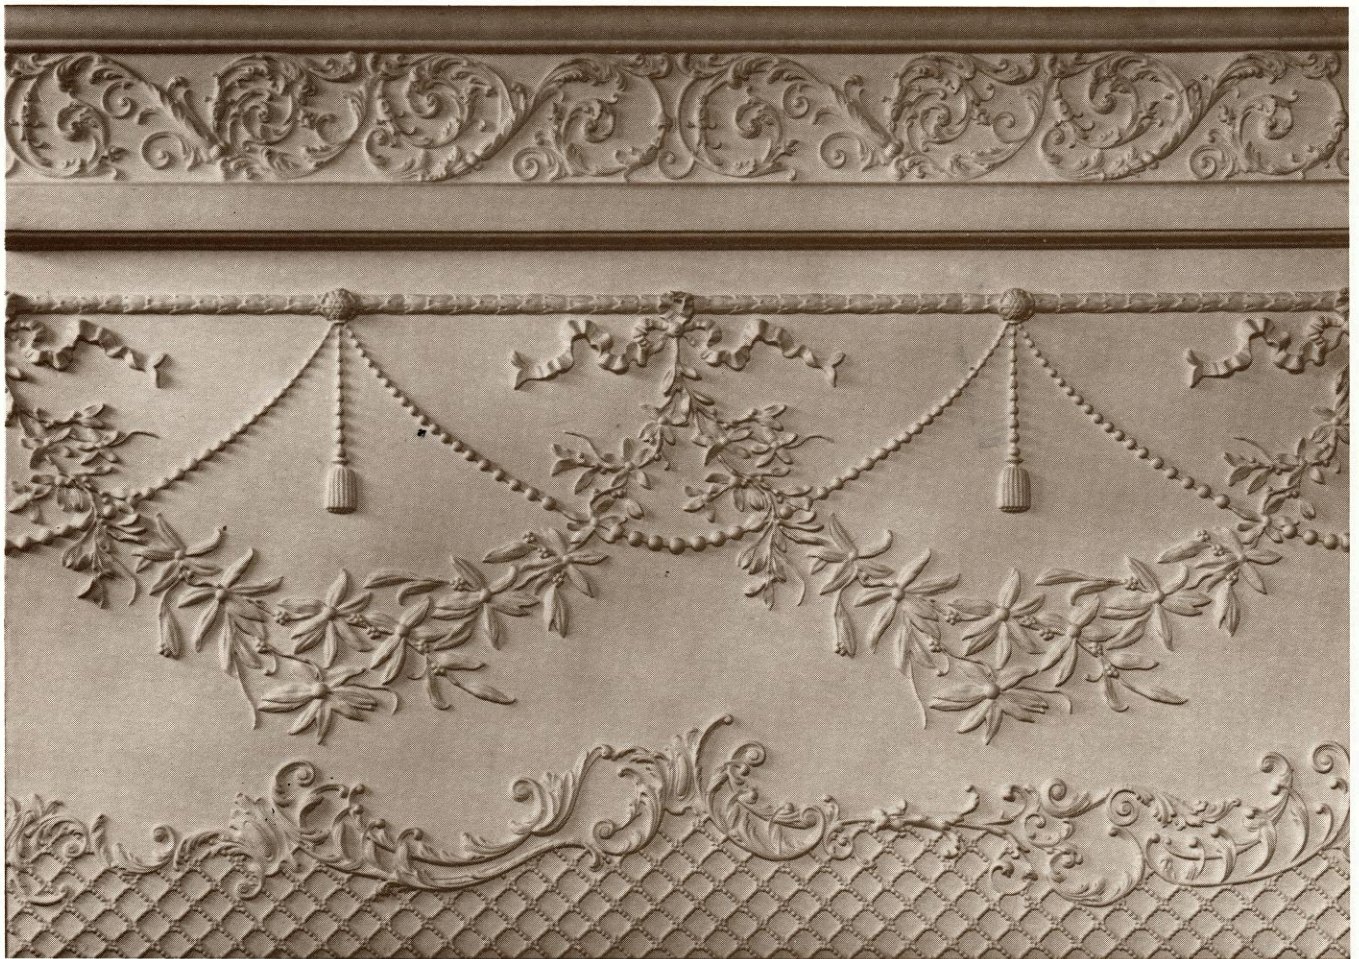
*This is a photograph of one of the pre-cast plaster friezes that was installed in the building. A smooth plaster panel was made. Using individual pieces of composition ornament the original design was carefully emulated. A mould was made of the entire piece, including the mini-frieze, and the panels were cast with all of the fine relief decoration integral, later to be installed in the building.*

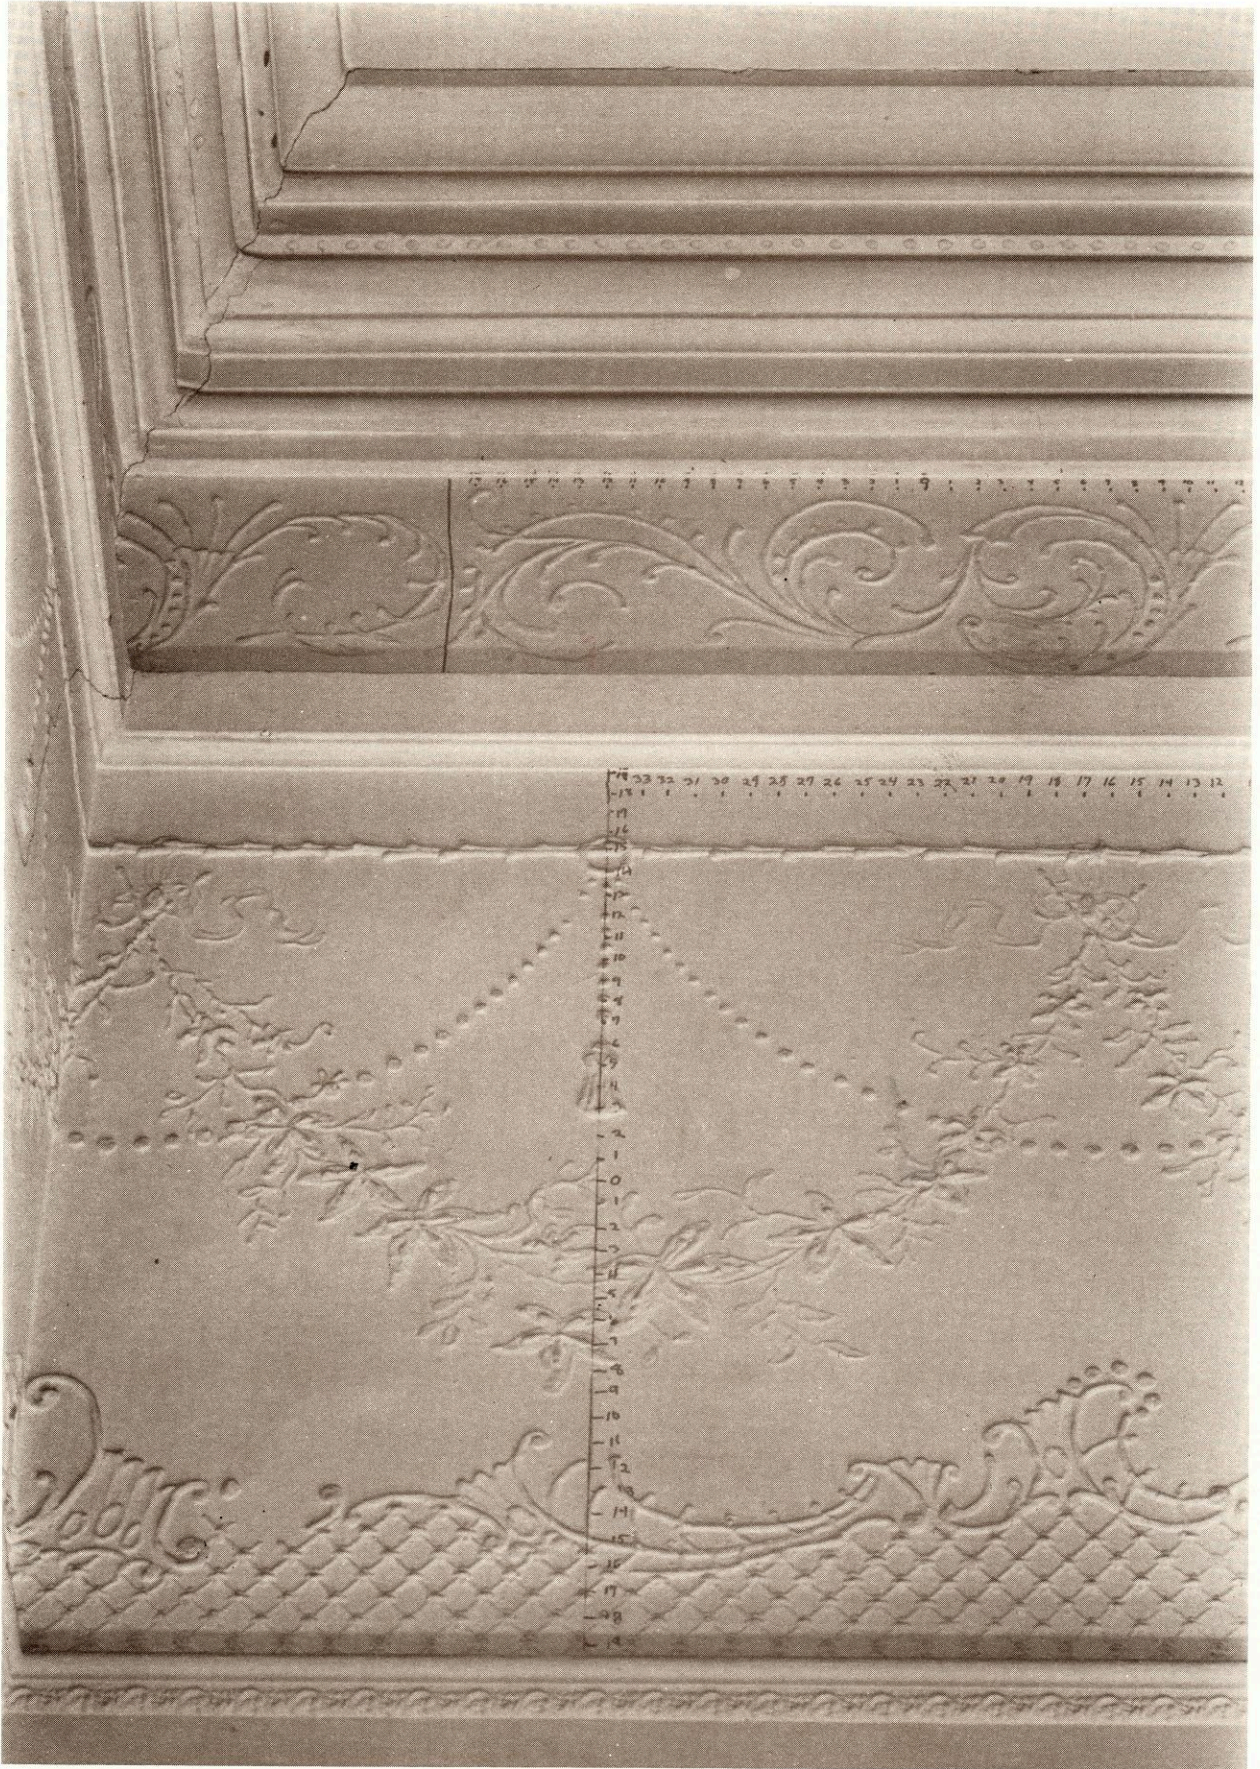
Room 1-25 Frieze Design

*This is a photograph of the surviving original work (1975). The picture demonstrates the relationship between the mini-frieze and the main frieze and its location to the large cornice moulding. Note the*

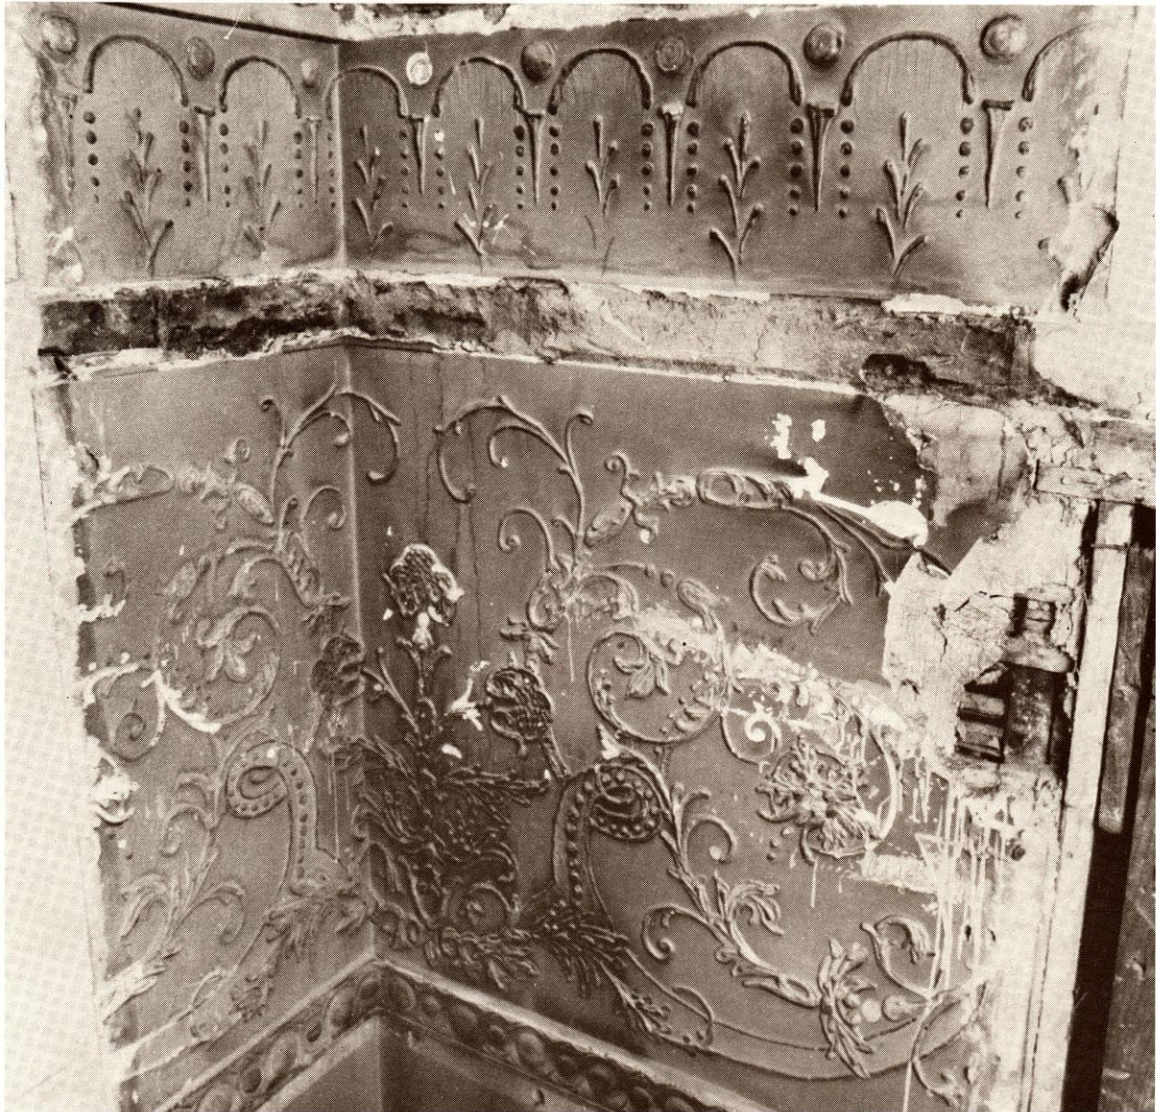
*As the Capitol Building was being dismantled this frieze was discovered under what had been a vent that had been installed around the turn of the century. Fortunately it was installed right over the original art work, preserving the design and original colour.*

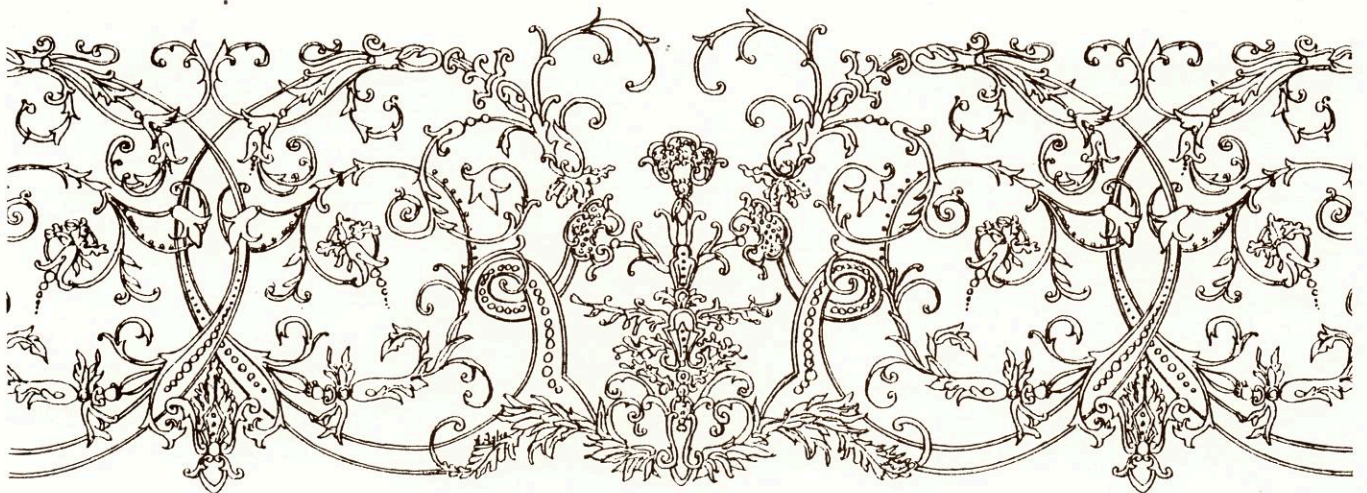
Room 1-28 Frieze

*This drawing shows how the design was replicated. The original link that tied the design repeat together was missing. The line flow that remained was followed through, and using the knowledge*

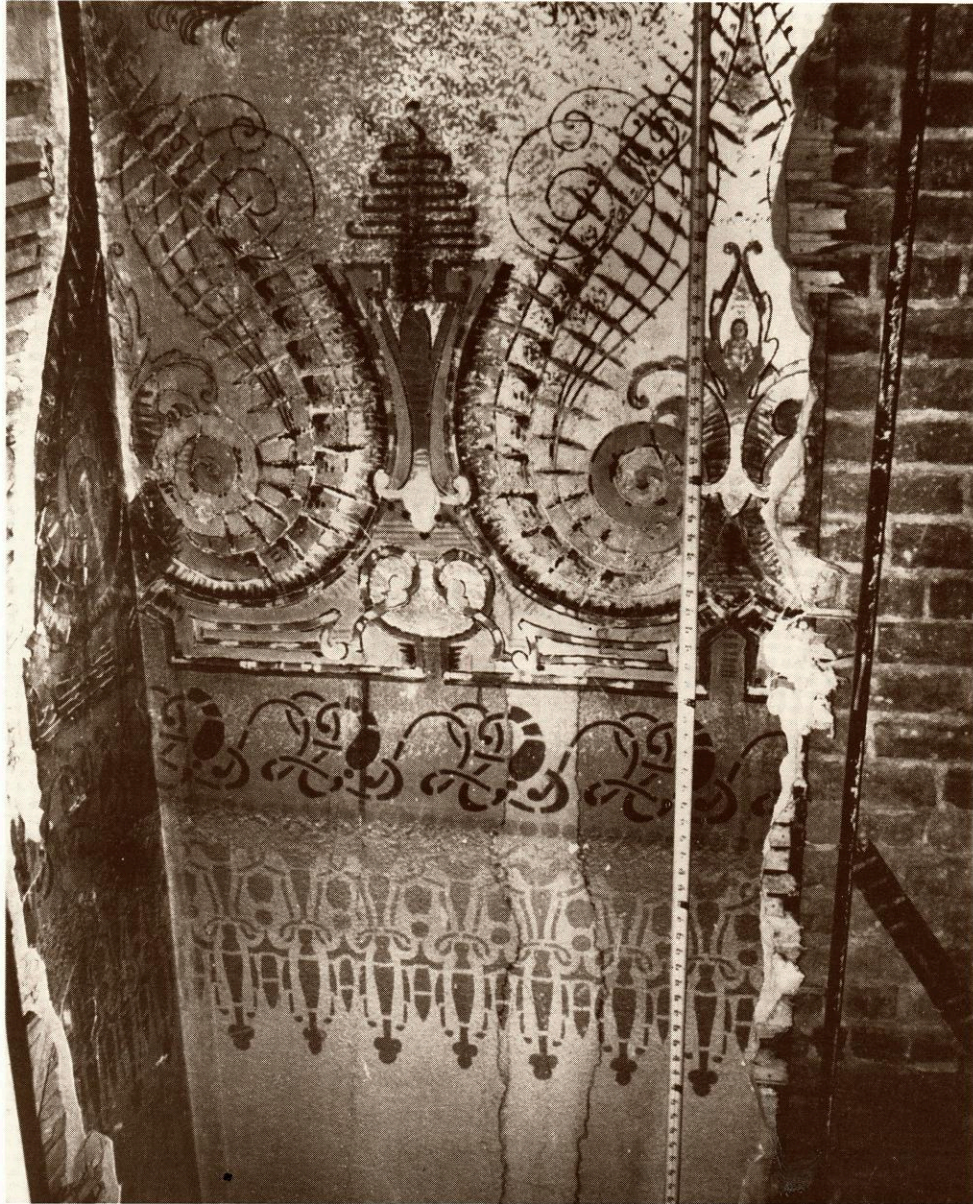
*South Wing Frieze*

*This is another frieze design that was discovered in the demolition of the building. This was a dramatically coloured polychromatic design with very low relief, half round outlining. From a distance*
